TECHNICAL REPORT REMR-CO-3

CASE HISTORIES OF CORPS BREAKWATER
AND JETTY STRUCTURES

Report 7

NEW ENGLAND DIVISION

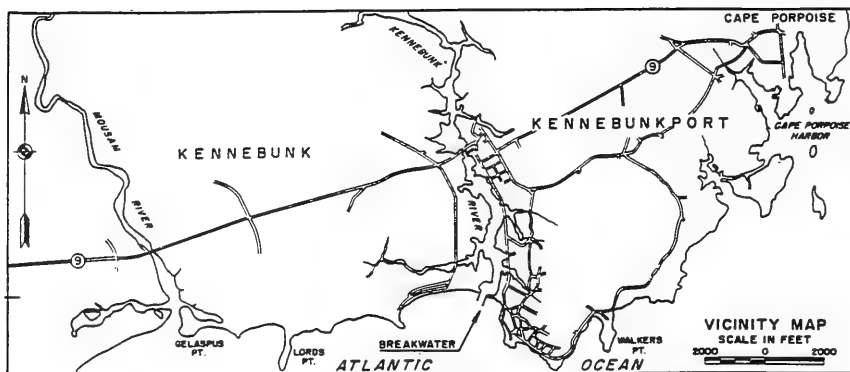
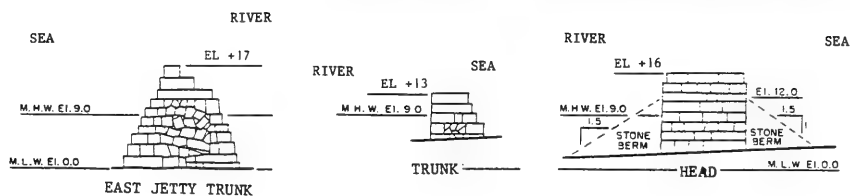
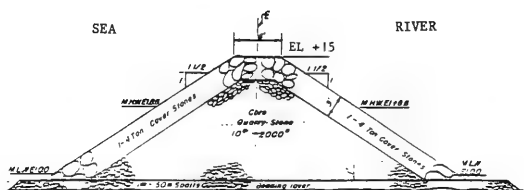
Figure 13. Plan view and typical cross sections of Kennebunk River jetties, Kennebunk, Maine

1931	The east jetty was repaired by resetting 300 tons of wall stone, placing 212 tons of rubble stone, placing 165 cu yd of concrete, and adding 50 iron pins to the capstone for a total cost of \$3,000.
1935	The jetties were repaired by resetting 85 tons of wall stone, placing 504 tons of rubble stone, and placing 20 cu yd of concrete for a total cost of \$2,800.
1954	Three sections of the east jetty, totaling 59 lin ft, were repaired by replacing stone to the general dimensions of adjacent undamaged sections of the jetty. Cost of the repairs was \$9,400.
1962	The jetties were repaired by resetting stone and placing concrete at several locations, and a stone berm was placed around the west jetty stone pier. The repair sections were typically 1 to 8 cu yd in volume. The stone berm around the west jetty head was placed to an elevation of +12 ft mlw and a 1V:1.5H side slope, and it consisted of stone weighing a minimum of 2 tons. Total cost of the repairs was \$12,900.

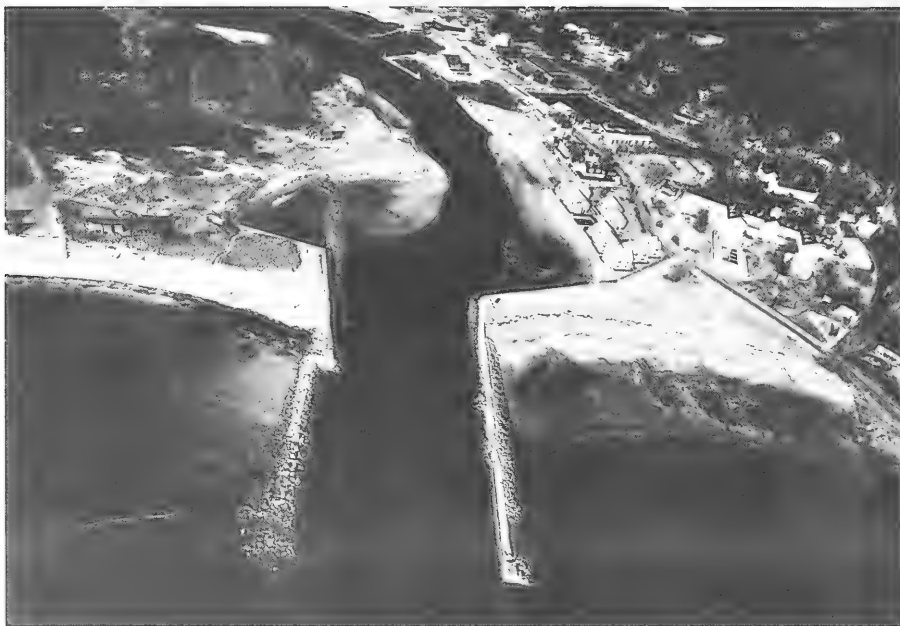
Figure 14. March, 1981 photograph of jetties at the mouth of the Kennebec River, Maine

1977- 1978	Visual inspections indicated the jetties were in poor condition. On the east jetty the seaward side of the head (stone pier) was severely damaged, void spaces in the seaward slope armor stone were evident, and the channel side toe was in a deteriorated state due to undermining. On the west jetty extension the outer 150 ft had large amounts of displaced cover stone with typical elevations from +6 to +13 ft mlw. The remainder of the extension was in considerably better shape with only minor displacement and settlement of the armor stone.
1981	The jetties were repaired with armor stone along the damaged sections observed on previous inspections and a topographic survey. The channel side of the east jetty, from 1+66 to 3+80, was repaired with 5- to 8-ton stone placed to an elevation of +12 ft mlw, a 1V:1H side slope, and a top width varying from 0 to 4 ft. The east jetty's seaside was repaired between 4+20 and 5+24 using 5- to 8-ton stone

Date(s)	Construction and Rehabilitation History
1981 (cont.)	placed to a +16 ft mlw crown elevation. The crown width and side slope were 6 ft and 1V:1.5H, respectively, except seaward of 5+00 where they were 30 ft and 2V:1H, respectively. The seaward 200 ft of the west jetty was brought up to the original design geometry with 3- to 5-ton and 3- to 7-ton stone on the trunk and head sections, respectively. Total cost for placing 2,100 tons of stone was \$99,000. Figure 14 is a photograph of the jetties taken prior to the repairs.
1986	Present conditions of the jetties are not known.

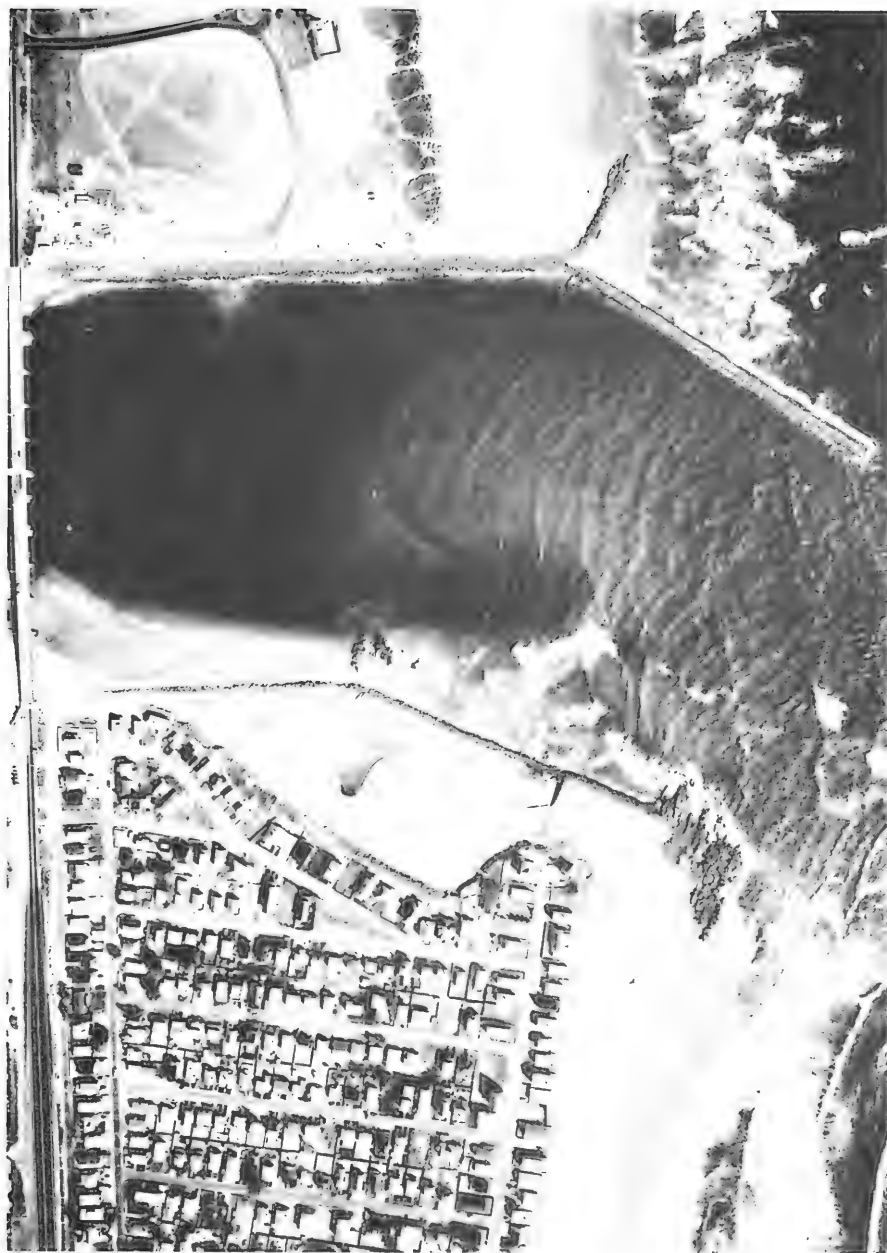
Figure 19. October 1984 photograph of jetties at Hampton Harbor, N.H.

1984	The jetties were inspected and found to be in excellent condition. Figure 19 is an aerial photograph of the jetties taken on 16 October 1984.

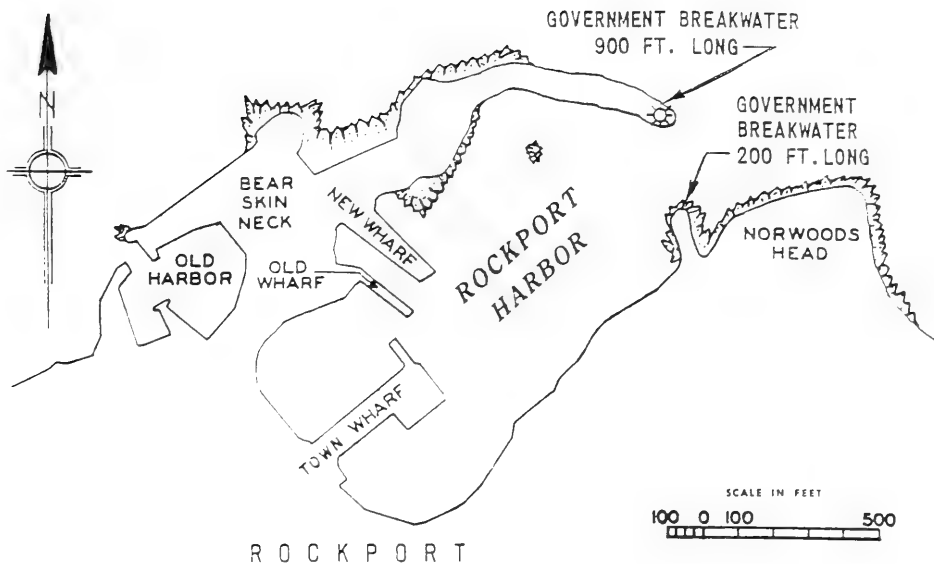
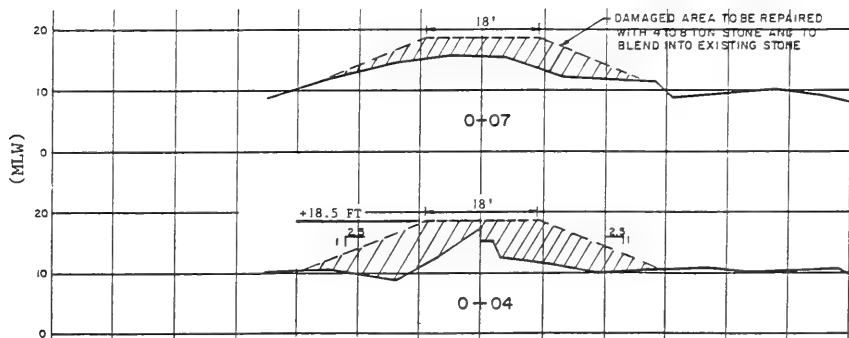
Figure 22. Breakwaters at Rockport Harbor, Mass.

1970	Repairs were made at the seaward end of Bearskin Neck breakwater where stone had been displaced from a lower portion of the head side slope. The existing head section cover layer had a fairly smooth appearance due to careful placement and addition of concrete grout. Also, iron tie rods had been placed, connecting individual cover stone throughout this section. The remainder of the breakwater is composed of 500-lb to 5-ton stone with an outward appearance typical of rubble-mound structures. The 45-ft-long repair section was located mostly on the harbor side quadrant of the head. Stone weighing 5 to 8 tons was placed at a 1V:2H side slope. The repairs were made for a lump sum of \$25,500.
1973	The seaward end of Bearskin Neck breakwater was repaired with 5- to 8-ton stone. The stone was placed on two sections, one totaling 55 ft in length on the seaside head and trunk and the other totaling 50 ft in length, the same area repaired in 1970. The repairs consisted of adding stone to void areas such that the resulting side slopes were fairly uniform. Lump sum cost of the repair was \$28,700.

1977- 1978	Repairs were made to the seaward 100 ft of Bearskin Neck breakwater. Existing displaced stone was reset throughout this section and, to complete the repairs, approximately 1,600 tons of new 4- to 8-ton stone were used. The repair geometry had a +18.5 ft mlw crown elevation, a crown width varying from 18 to 28 ft (widest at seaward end), and side slopes varying from 1V:2.5H to 1V:1.5H (steepest at
